### **DARRINGTON ROAD REPAIR PROJECTS**

Heavy rains during the 2016 winter damaged numerous roads and trails across the Mt. Baker-Snoqualmie National Forest, including several roads within the Darrington Ranger District. The Forest is working to restore access for Forest users by repairing roads that have experienced storm-related damage while also maintaining aquatic and wildlife habitat standards.

#### **DESCRIPTION OF PROJECTS**

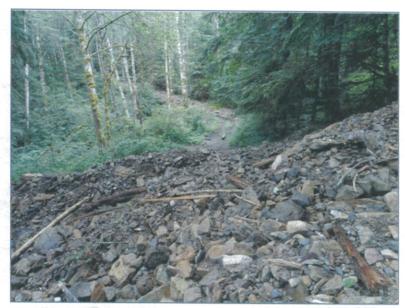
Figure 2.Peekaboo Road (FSR 2083) at MP 0.1

Two slides 70-feet apart have deposited storm debris on the roadway. Debris covers the roadway 9-feet deep for 132-feet at one site and 2-3-feet deep for 260-feet at the other site. Proposed repairs would include removing remaining debris, resurfacing 300 feet of road, and replacing culverts (one 36-inch pipe and one 48-inch pipe).

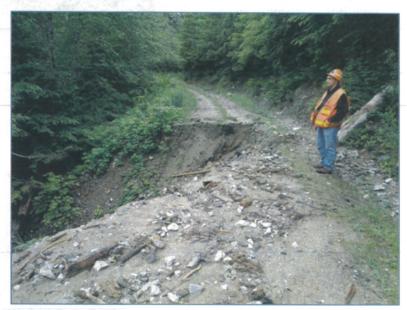
Figure 3. Rat Trap Pass Road (FSR 27) at MP 6.9

Storm debris flowed into the roadway, plugging a culvert, depositing debris on the road, and eroding the roadway. Proposed repairs would blade and shape 800-feet of road, regrade the road for 236-feet, re-shape ditch scour for 253-feet, and resurface 800-feet of the road. Repairs would also include construction of a mechanically stabilized earth (MSE) retaining wall. Existing culverts would be cleaned out and one new culvert installed.

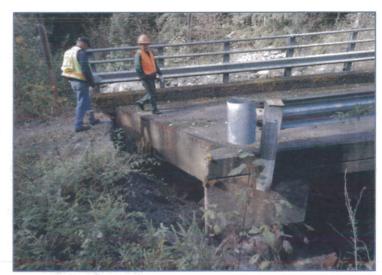
Figure 4. Upper Tenas Creek Bridge at MP 4.2

Tenas Creek scoured away the toe of the roadway embankment and caused failure of the road and bridge approach. Proposed repairs would armor the west abutment of the bridge with heavy riprap and replace the approach embankment.

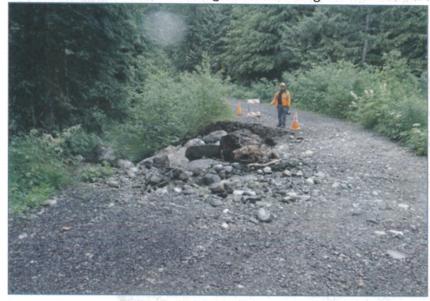
Figure 7. Sunrise Mine Road (FSR 4065) at MP 1.15

High water flows caused the road embankment above the "over-flow" culvert to fail. Storm debris also accumulated at the outlet of main culvert. Repairs would include replacing the failed road embankment and removing debris blocking the main culvert outlet.

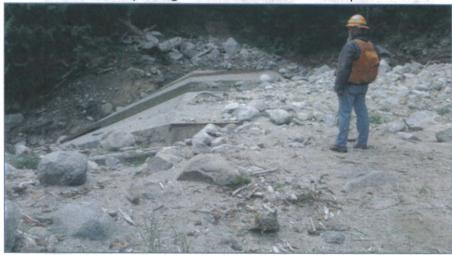
Figure 8. Deer Creek Road (FSR 4052) at MP 2.55

A debris slide damaged 100-feet of road above the ford as well as the ford. Proposed repairs would remove slide debris from the culvert inlet, re-establish the roadbed and replace 275' of aggregate surfacing. The ford would be repaired at the outlet by removing the bottom 4 feet of the structure and replacing it with a formed concrete pad runoff.

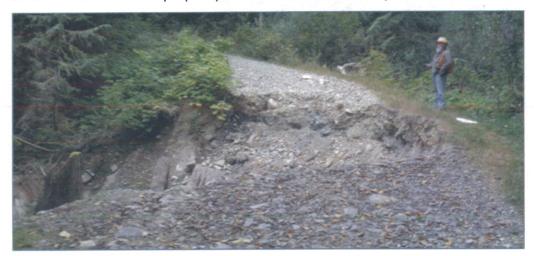
Figure 9. Deer Creek Road (FSR 4052) at 3.0

High flows overtopped the existing 9' diameter culvert, causing the road bed above the culvert to wash away. Proposed repairs would replace fill, re-establish the roadbed, and replace the aggregate surfacing. Trees blocking the culvert outlet would be removed, large riprap would be placed under the scoured eroded portions of the culvert. At the culvert inlet, damaged riprap would be repaired to original lines and grades. Work would also include constructing embankment fill with riprap slope rock from onsite nearby materials.

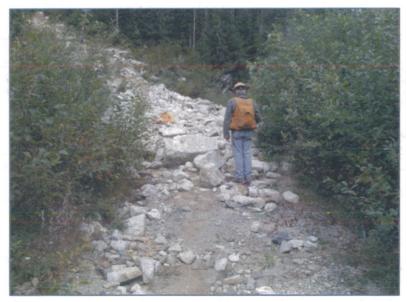
Figure 10. Deer Creek Road (FSR 4052) at 3.7

Rainfall caused slide material to run down slope onto the road. Proposed repairs would remove slide material and restore drainage through installation of a new cross drain. Slide material would be hauled to a nearby designated waste area and stockpiled.
